Chum Creek
Landcare

CHUM CREEK LANDCARE NEWSLETTER

No. 13, Summer, 2017-2018

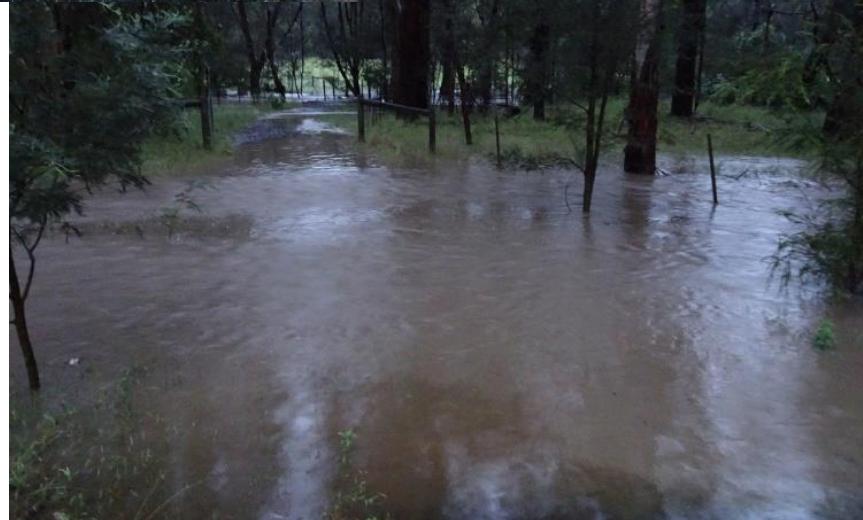
Droughts and flooding rains affect Chum Creek, as illustrated by these 2 photos taken in almost identical locations on your editor's property on the Sunday after Black Saturday in 2009 (left) and on Saturday, 4 December, 2017 (right)

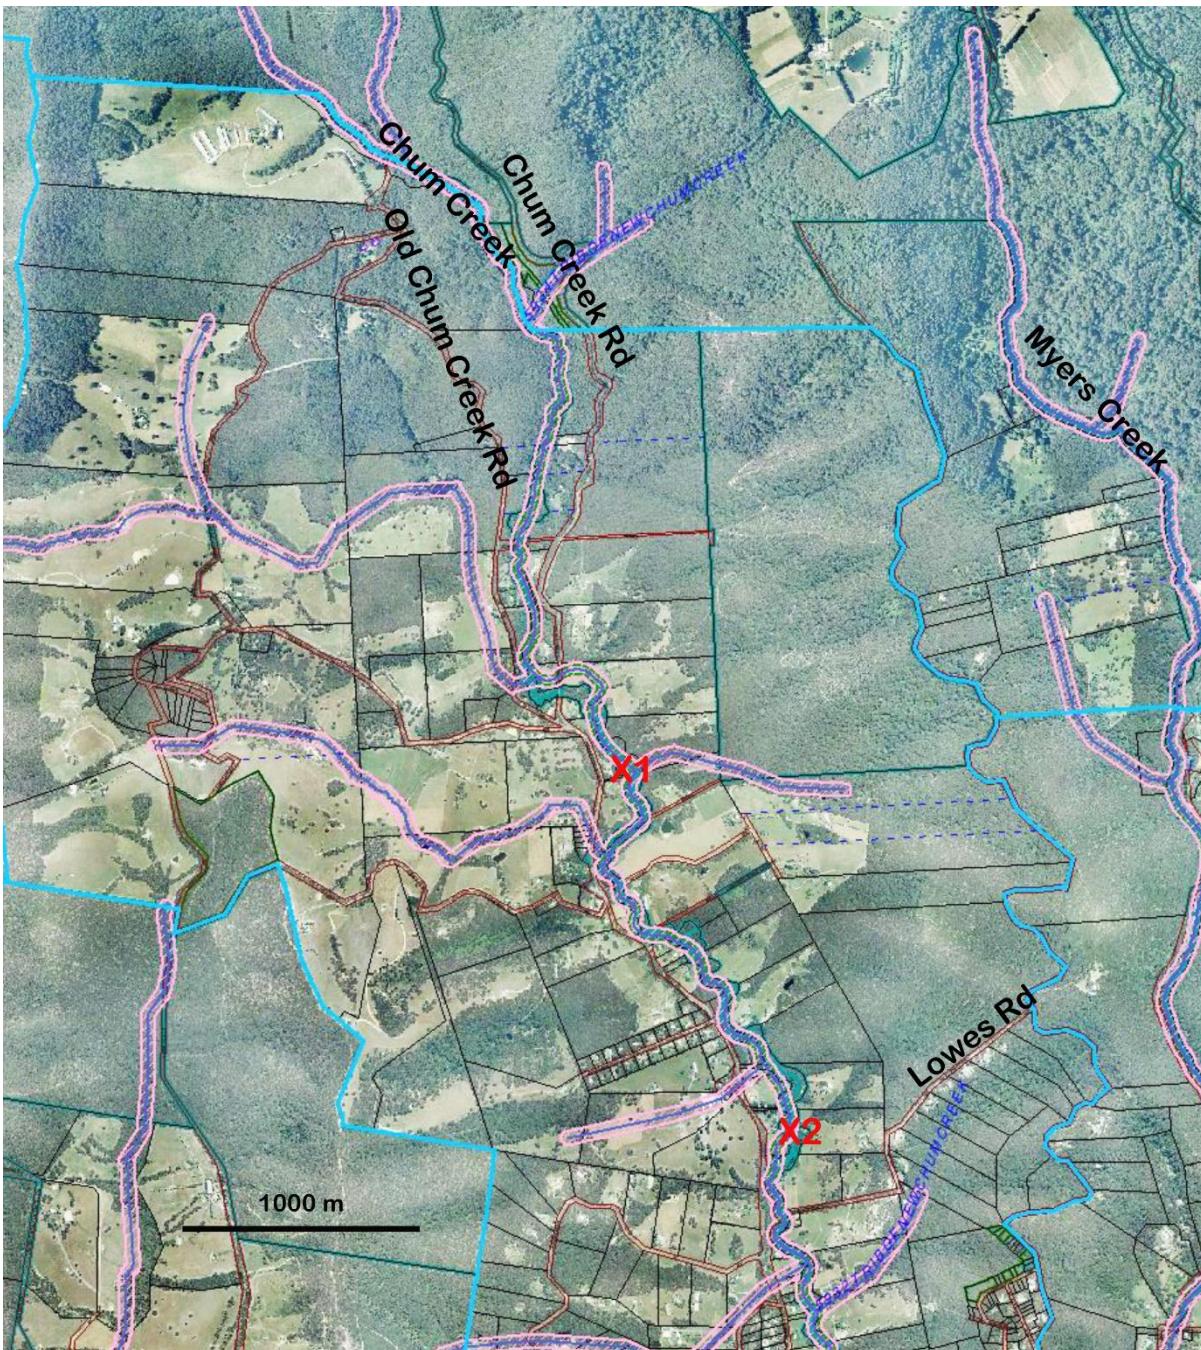
Chum Creek Landcare received a grant from Melbourne Water to purchase some simple instruments to measure the physical, chemical, and biological quality of Chum Creek. Two sampling sites were selected, based on those who volunteered to participate (we thank Beth Bagley for assistance) – one just downstream of the junction of Heath, Old Chum Creek, and Chum Creek roads where Chum Creek flows through 762 Chum Creek Rd. (X1 in the map on P. 5), and the other just upstream of the Yumbunga dam where Chum Creek flows through 420 Chum Creek Rd (X2 in the map). The distance between the 2 sampling locations is approximately 1.8 km. Both sites are in the middle section (mixed forest and agriculture) of Chum Creek.

Sampling was conducted at both locations at approximately the same time (30 – 60 minutes earlier at the upstream site – X1) slightly more than once a month for the 2016 year (13 samples from each sampling site for the year). Water quality parameters measured were –

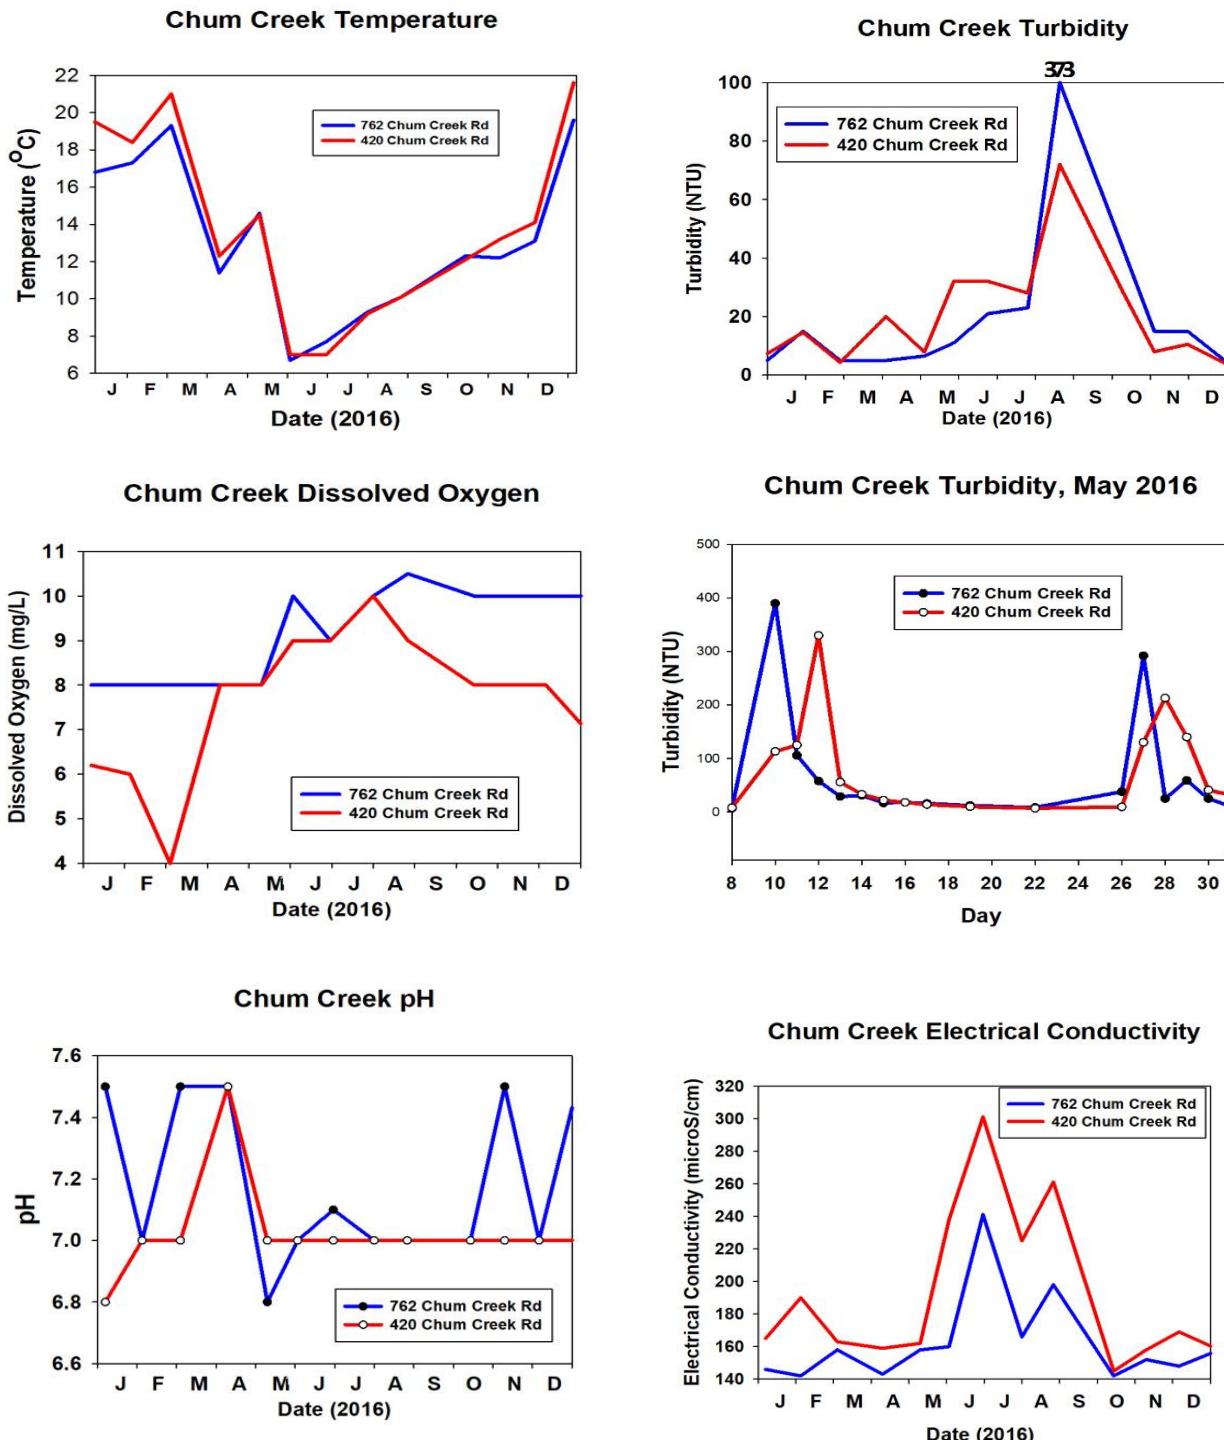
Trends in water quality parameters measured during 2016 and during one month (May) in 2016 for turbidity. The lowest turbidity measured was 4.3 NTU (vs 0.5 NTU as the drinking water quality maximum).

The results suggest that Chum Creek water quality is questionable at times. Rainfall causes relatively high sediment loads (see Figures on P. 6) which may not always be detected by infrequent (e.g. once per month, perhaps during May 15-26, 2016) sampling. Biological contamination is likely throughout the year (coliforms were detected in one or both samples every month except April), and dissolved oxygen levels became relatively low at the downstream site in March, threatening aquatic life. The water did not meet drinking water

standards for turbidity at any sampling (should not exceed 0.5 NTU at any time, but every measurement exceeded this), although it met pH standards. It is still unclear how water quality varies along the creek and the degree to which biological contamination occurs. The presence of total coliforms is suggestive, but not conclusive. Perhaps we might do a more rigorous sampling in the future.
